**IN Cell Analyzer**  
**Acquisition Software, Version 4.5**  
**Release Notes**

March 11, 2014

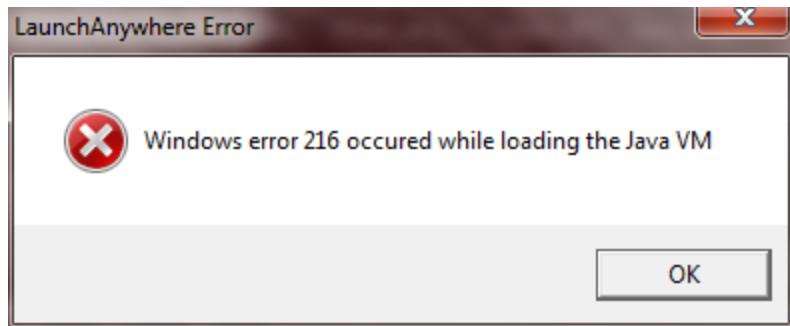
Installation packages are named according to the instrument model. Be sure to choose the installation package that matches the instrument. Look for "2000", "2200", or "6000". For workstations running 64-bit Windows7, use installation packages that contain "x64" in the file name. Packages that do not contain "x64" in the file name are intended for workstations running 32-bit Windows (XP or Windows7). Attempting to install the 64-bit package on a workstation running a 32-bit operating system will result in the error message shown here.

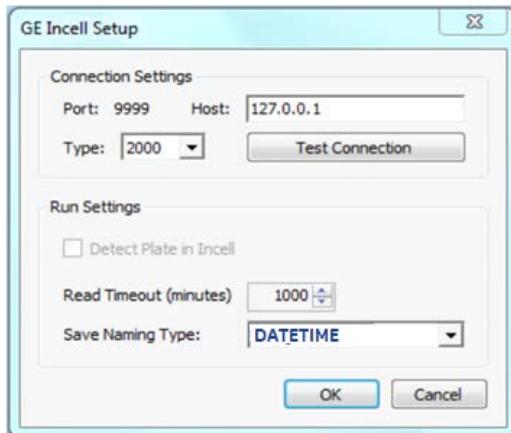
- Set the "Save Naming Type" to "DATETIME" rather than "UNIQUE". Generating unique folder names can be very time consuming (on the order of 10-60 seconds) when working with certain types of remote file storage, e.g., "Network Attached Storage (NAS) performance".

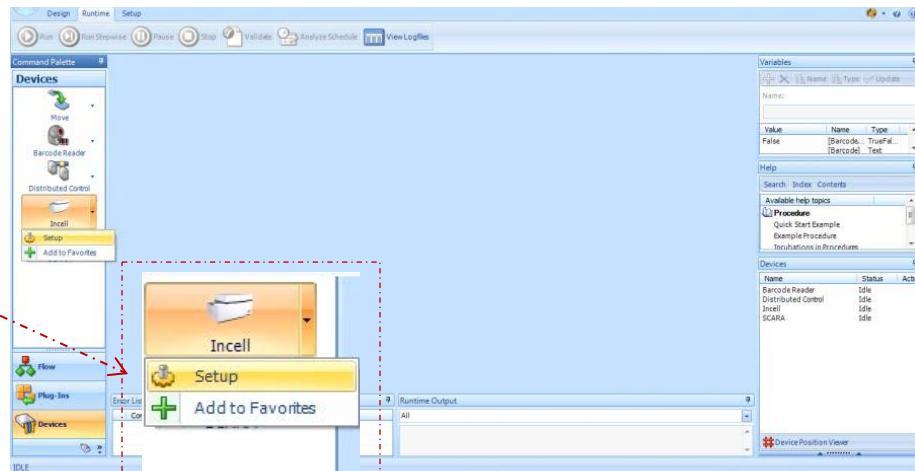
- Overlord timeout during long scans (driver version < 1.0.3.10).  
Scans that last longer than the Overlord "Read Timeout" value may result in a communication failure between Overlord and IN Cell. To workaround this problem, increase the device communication **Read Timeout** value to a value that is larger than the time required to scan a plate. Using a large timeout such as 1000 minutes will prevent a communication problem between the IN Cell acquisition and Overlord software.
  1. Open the **Overlord** software by clicking the desktop icon or navigating to C:\Users\incell\AppData\Local\Programs\PAA\Overlord3\Overlord.Main.exe. The **Overlord** console opens.
  2. Under **Devices**, right-click **Incell** and select **Setup** from the pop-up menu.

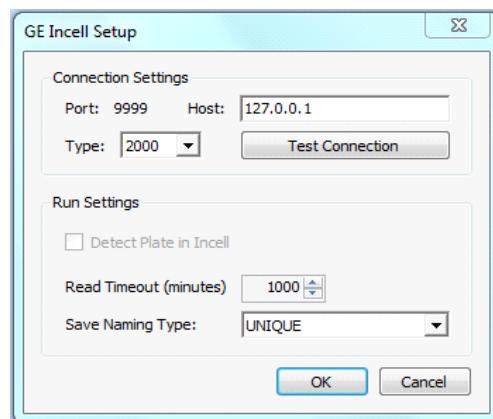
3. On the **GE Incell Setup** dialog, increase the **Read Timeout** interval to 1000 minutes. Click **OK** to save and close the dialog.
