# **IN Cell Analyzer**

## **Acquisition Software, Version 5.2**

### **Release Notes - Patch 1**

#### **16 October 2015**

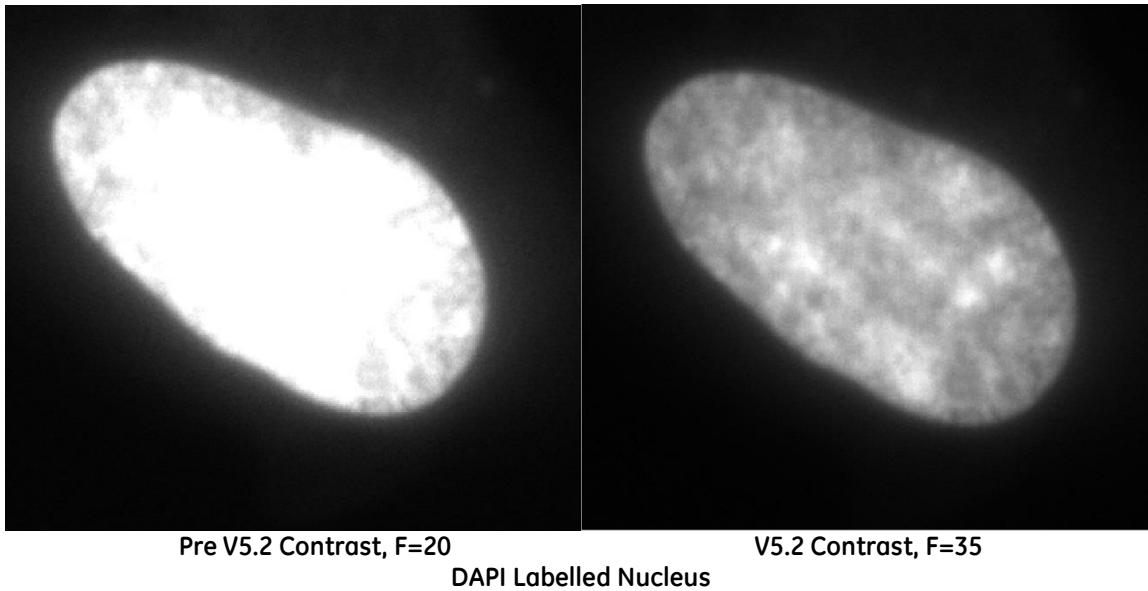
The existing auto-contrast factor works well for most channels, although DAPI labelled nuclei are sometimes displayed with too much saturation. In the following figure, the original display setting ( $F=20$ ) is shown on the left and the new display setting ( $F=35$ ) is shown on the right. Only the display settings for DAPI have been changed in V5.2. All other channels will continue to use the previously defined setting of 20. To customize the settings for a specific channel, refer to ID 1359 in the summary table at the end of this document.
