# IN Cell Analyzer

## Acquisition Software, Version 5.1

### Release Notes

28 April 2015

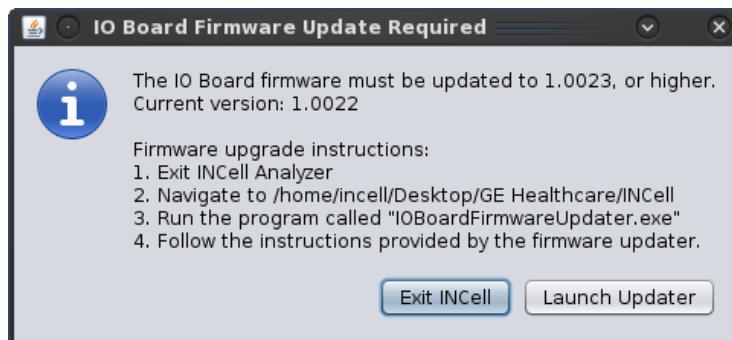
Most of the checks are intended to determine whether an upgrade is available and recommended. Certain types of incompatibilities, however, will prevent operation. When appropriate, the IN Cell software will offer to launch the appropriate firmware upgrade program, as shown in the following example.
