IN Cell Analyzer

Acquisition Software, Version 7.3

Release Notes

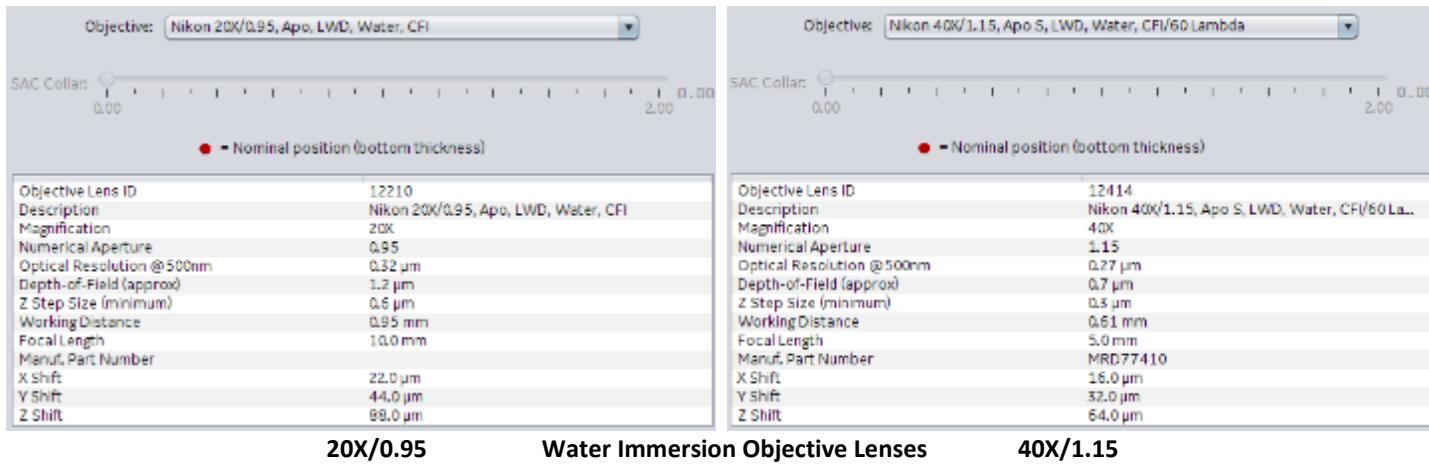
Water Immersion Lenses

Immersion optics can now be used within the INCell. A technical description of the supported lenses (2) is contained within the screenshots below.

Objective Lens ID	12210
Description	Nikon 20X/0.95, Apo, LWD, Water, CFI
Magnification	20X
Numerical Aperture	0.95
Optical Resolution @500nm	0.32 μm
Depth-of-Field (approx)	1.2 μm
Z Step Size (minimum)	0.6 μm
Working Distance	0.95 mm
Focal Length	10.0 mm
Manuf. Part Number	
X Shift	22.0 μm
Y Shift	44.0 μm
Z Shift	88.0 μm

Objective Lens ID	12414
Description	Nikon 40X/1.15, Apo S, LWD, Water, CFI/60 Lambda
Magnification	40X
Numerical Aperture	1.15
Optical Resolution @500nm	0.27 μm
Depth-of-Field (approx)	0.7 μm
Z Step Size (minimum)	0.3 μm
Working Distance	0.61 mm
Focal Length	5.0 mm
Manuf. Part Number	MRD77410
X Shift	16.0 μm
Y Shift	32.0 μm
Z Shift	64.0 μm

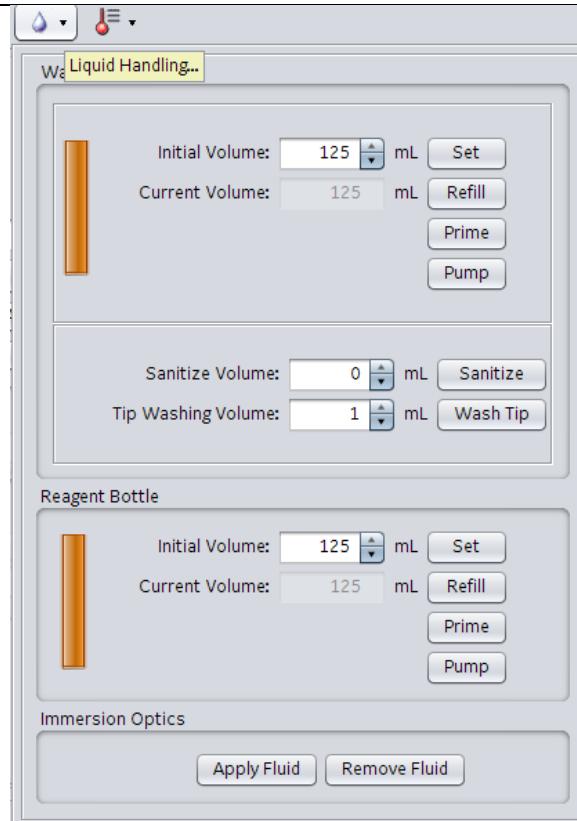
Interactive Controls for Immersion Fluid

The software provides two basic methods of controlling the immersion fluid: 1) interactive control using the liquid handling dialog, and 2) automated control during scanning using settings in the acquisition protocol. Screenshots of the controls are shown below. Look for tooltips that explain the buttons and provide important details.

INCell's immersion optics system is based on the liquid handling (LH) sub-system, an optional feature of the INCell product line. Immersion fluid is applied to and removed from the tip of the objective lens using the LH needle, which can be located directly above the objective lens. Among the benefits of this approach is that the objective lens is not encumbered with extra tubing or water delivery mechanisms. The full working-distance is available for scanning plates. INCell's water immersion lenses can reach more wells than a lens that has complicated additions to tip. Another benefit of using the LH needle is that the possibility of leaks and complications near the scanning mechanism are reduced. The LH needle is only present during application and removal of fluid, and the fluid quantities are small.

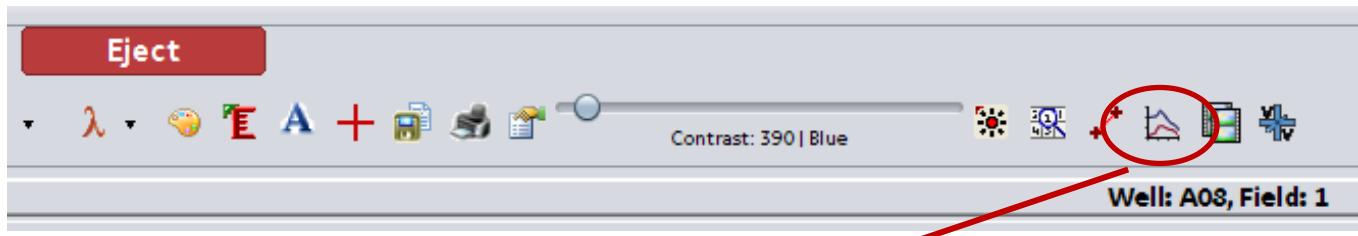
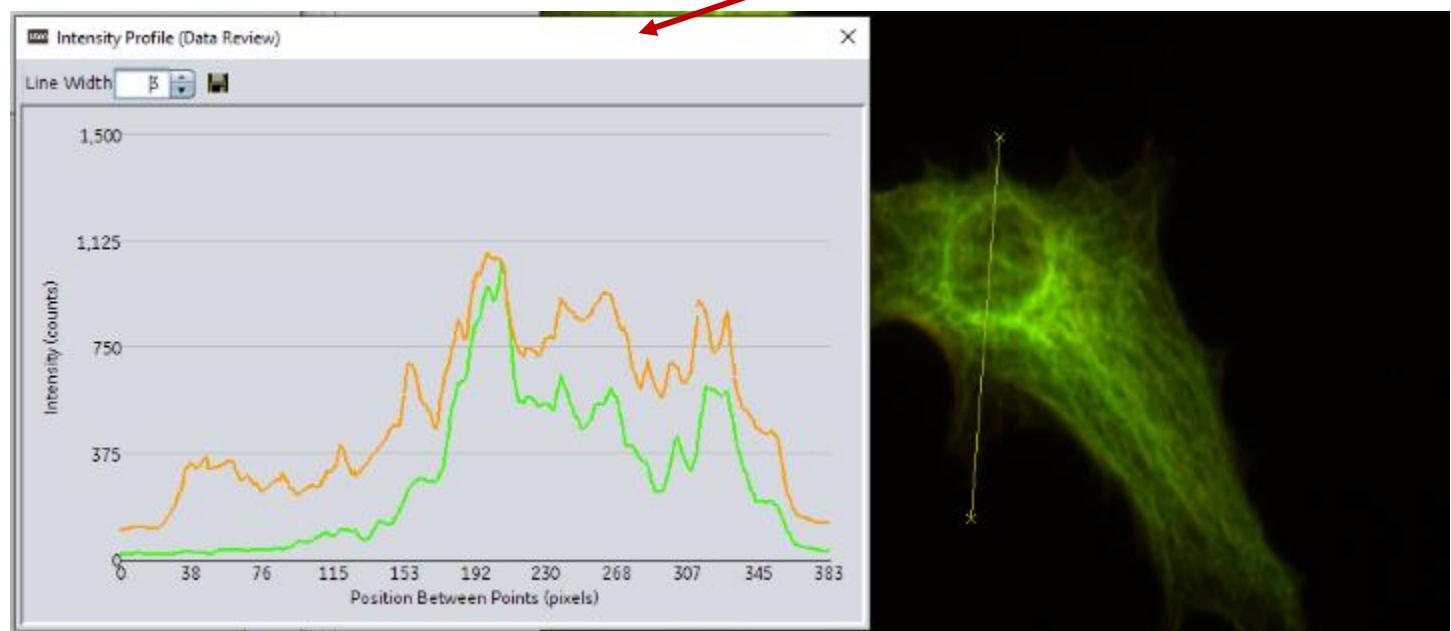
A line profile graphing tool has been added to both the *Setup* and the *Review* pages. Launch the tool with the button shown below. Select two points in the image to generate a new graph. The tool will remember all selected points until between the time of launch and the time of close. Press the disk icon to save the profile(s) to a CSV file. Line profiles created within *Setup* mode are limited to a single channel/wavelength. For multi-channel line profiles, acquire data with a scan and then generate line profiles within the *Review*.

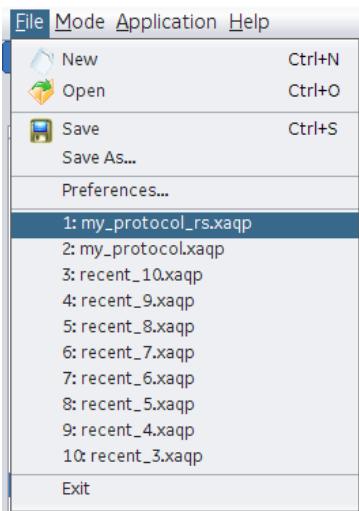
Recently Used Protocols with New *ReviewScan* Protocol

Once created according to the rules above, the new protocol will be automatically saved. The new protocol will also be added to the list of most recently used protocols for easy access.

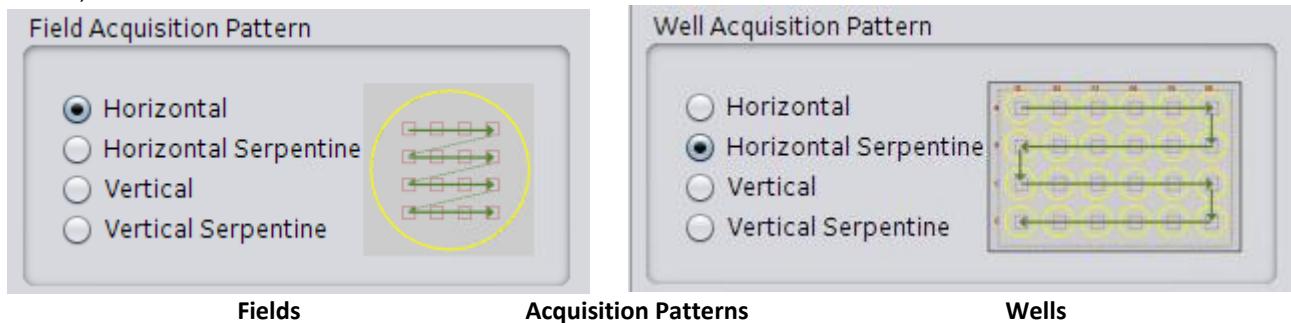
Prior versions of software used the same graphics and terminology for both field and well acquisition patterns. The only way to distinguish the two was by context. To help identify the purpose of these control settings, the graphics and associated tooltips are now different, as shown below.

2580	Clarify what RAM level is reported in the About page	The displayed amount of RAM corresponds to the Java VM used by INCell.
2581	Field Acquisition Pattern has misleading graphics.	Similar to 2628. The graphics are now appropriate.
2582	Remote control interface should not accept the <i>StartScan</i> command unless in the correct state (Waiting for StartScan, 3)	INCell should not accept the <i>StartScan</i> command unless the instrument is in the correct state. The correct state is "Waiting for StartScan". Prior to V7.3, INCell was not careful enough. A variety of failures, including a software stall, were possible.
2584	Prompt user to update firmware for LH	The latest firmware is needed for proper control of the liquid handling axes LHY and LYZ.
2586	Acquisition client freezes with Hudson robot	defect
2600	Improvements to the <i>AutoOffset</i> measurement procedure.	The Cancel button has been moved to the results dialog where the operator can choose to accept or cancel the measurement. Also, the AF offset values in the protocol settings part of the GUI are properly updated after the measurements. Also see 2614.

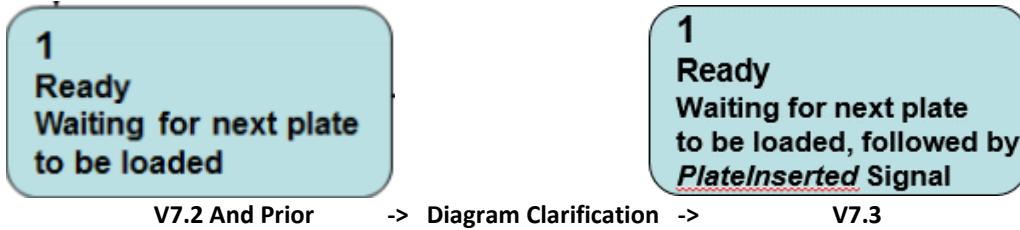
PlateInserted has always been a required message for advancing the state of the INCell while in remote control mode. This fact was not properly described in the protocol document. The essence of the change is provided in the updated version of the state machine diagram, as shown below. Additionally, a warning message will be recorded in the INCell log file if *PlateInserted* is used while INCell is in any other state. *PlateInserted* is only appropriate when INCell is presently in state 1.

2637	Update LH integration scripts	The scripts used for building and maintaining instruments with the LH sub-system have been improved. Some of the changes were needed for the water immersion option.
2642	Incorrect Text in Instrument Controller Software Update Required Message box	The instructions referred to "INCellICServerUpdater.exe", but the correct name of the program is "INCellICServerInstaller.exe"
2643	Improve handling and documentation of RC command "PlateInserted".	<p>The RC protocol document fails to describe how the "PlateInserted" command is needed for starting the load delay. The client must use "PlateInserted" in order to start the load delay and thereby prepare INCell for the ensuing "StartScan" message.</p> <p>At least two basic changes are needed:</p> <ol style="list-style-type: none"> 1. the protocol document should clarify the need for PlateInserted 2. INCell should present a warning if PlateInserted is used improperly (INCell must be waiting for the next plate, otherwise PlateInserted doesn't make sense).
